**Flood Control Project Maintenance
Levee Inspections**
LMA District Cover Sheet
Spring 2019 Levee Inspection Results

Reclamation District No. 0784 Plumas Lake

Spring 2019 Levee Inspection Results

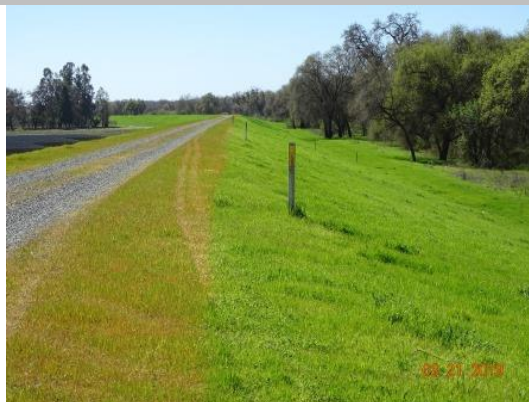
Photo 1 of 1 : SP_2019_RD0784_532_3_20190415_00006.jpg

LM Start	9.03	Rating **	A	Issue No.	3
LM End	12.74	Issue Type +	Ma	Location *	WS
Category	Earthen Levee			GPS Latitude/Longitude	
				Start	End
Item	Vegetation			39.009022 °	38.956310 °
				-121.578594 °	-121.575308 °
DWR ID	DWR_RD0784_02B_s_2019_3				
Comment Code					
V1 : Control annual grass and weeds on the levee slopes and easements.					
Inspector Comment					
The annual vegetation is well maintained, Spring 2019.

View looking downstream waterside at the well maintained annual vegetation, Spring 2019.

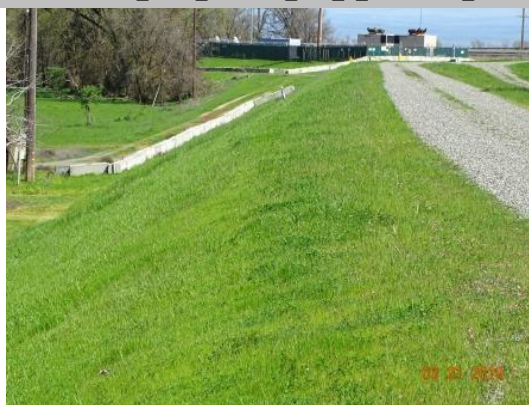
Photo 1 of 1 : SP_2019_RD0784_533_1_20190325_00001.jpg

LM Start	2.43	Rating **	A	Issue No.	1
LM End	3.19	Issue Type +	Ma	Location *	LS
Category	Earthen Levee			GPS Latitude/Longitude	
				Start	End
Item	Vegetation			38.970596 °	38.974692 °
				-121.547559 °	-121.535497 °
DWR ID	DWR_RD0784_03A_s_2019_1				
Comment Code					
V1 : Control annual grass and weeds on the levee slopes and easements.					
Inspector Comment					
The annual vegetation is well maintained, Spring 2019.

View looking upstream landside at the well maintained annual vegetation, Spring 2019.

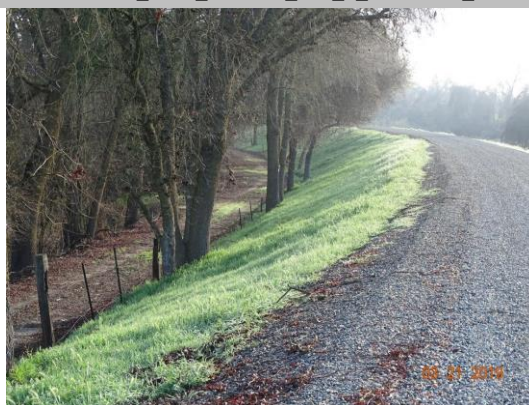
Photo 1 of 1 : SP_2019_RD0784_534_4_20190325_00005.jpg

LM Start	3.23	Rating **	A	Issue No.	4
LM End	4.69	Issue Type +	Ma	Location *	LS
Category	Earthen Levee			GPS Latitude/Longitude	
				Start	End
Item	Vegetation			38.974360 °	38.985496 °
				-121.532187 °	-121.510636 °
DWR ID	DWR_RD0784_03B_s_2019_4				
Comment Code					
V1 : Control annual grass and weeds on the levee slopes and easements.					
Inspector Comment					
Annual vegetation is well maintained, Spring 2019.

View Looking upstream landside of well maintained annual vegetation, Spring 2019.

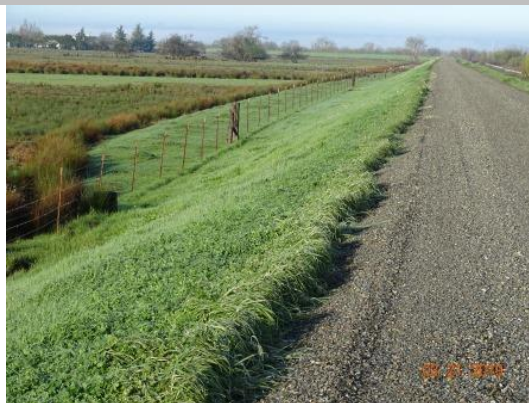
Photo 1 of 1 : SP_2019_RD0784_182_14_20190325_00034.jpg

LM Start	0.01	Rating **	A	Issue No.	14
LM End	4.19	Issue Type +	Ma	Location *	LS
Category	Earthen Levee			GPS Latitude/Longitude	
				Start	End
Item	Vegetation			38.974526 °	39.020566 °
				-121.532507 °	-121.509102 °
DWR ID	DWR_RD0784_05_s_2019_14				
Comment Code					
V1 : Control annual grass and weeds on the levee slopes and easements.					
Inspector Comment					
Annual vegetation is well maintained, Spring 2019.

View looking downstream landside of well maintained annual vegetation, Spring 2019.

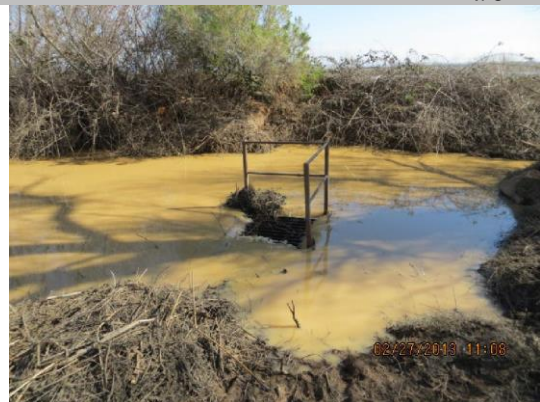
Photo 1 of 2 : UCIP_SP_2019_53546_54246.jpg

LM Start	0.84	Rating **	M	Issue No.	17
LM End	0.84	Issue Type +	Ma	Location *	
Category	Supplemental			GPS Latitude/Longitude	
				Start	End
Item	DWR UCIP LMA Responsibility			38.986432 °	38.986432 °
				-121.534983 °	-121.534983 °
DWR ID	18591				
Comment Code					
Inspector Comment					
FS_ID:53546 DS_ID:18591 EP_NO: N/A Repair Type: Non-Urgent Crossing Status: Found UCIP Comments: 2-1-2019 - Pipe crossing was video inspected on 8/14/2018. (P. Meagher)02/26/2013 No handle or access to slide gate on LS toe. (W. Wylie - DWR UCIP) FIELD_STRUCT_DESC: 30-inch corrugated metal drainage pipe through the levee, 23.7 feet below the crown. Flap gate on the waterside (WS) end. Slide gate inside a concrete drop inlet on the landside (LS). [Additional Reference(s): DWR Levee Log, 2005. USACE Sacramento O&M Manual 145, August 1955 (Station 63+00)]. FS Date: 9/11/2015 9:05:00 AM

Concrete drop-inlet at LS toe.

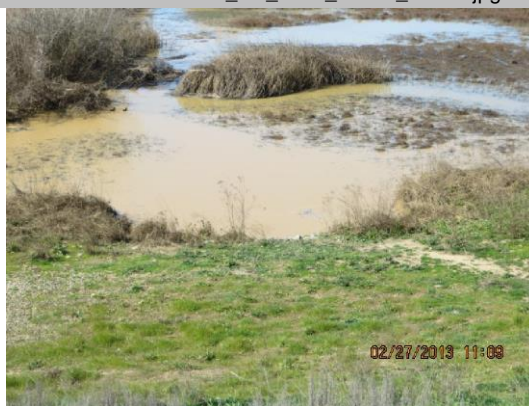
Photo 2 of 2 : UCIP_SP_2019_53546_54245.jpg

Comment Code						
Inspector Comment						
FS_ID:53546						
DS_ID:18591						
EP_NO: N/A						
Repair Type: Non-Urgent						
Crossing Status: Found						
UCIP Comments: 2-1-2019 - Pipe crossing was video inspected on 8/14/2018. (P. Meagher)02/26/2013 No handle or access to slide gate on LS toe. (W. Wylie - DWR UCIP)						
FIELD_STRUCT_DESC: 30-inch corrugated metal drainage pipe through the levee, 23.7 feet below the crown. Flap gate on the waterside (WS) end. Slide gate inside a concrete drop inlet on the landside (LS). [Additional Reference(s): DWR Levee Log, 2005. USACE Sacramento O&M Manual 145, August 1955 (Station 63+00)].						
FS Date: 9/11/2015 9:05:00 AM

Outlet with riprap on WS toe.

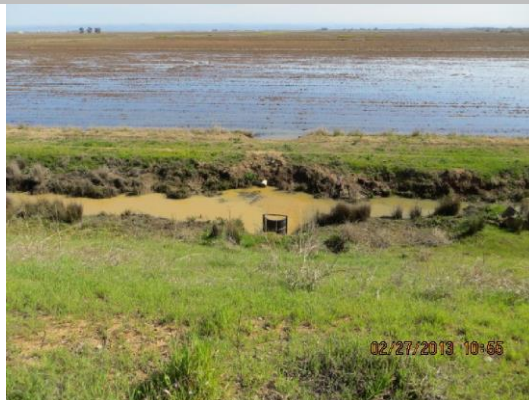
Photo 2 of 3 : UCIP_SP_2019_53547_16563.jpg

Pvc weir on inlet at LS toe.

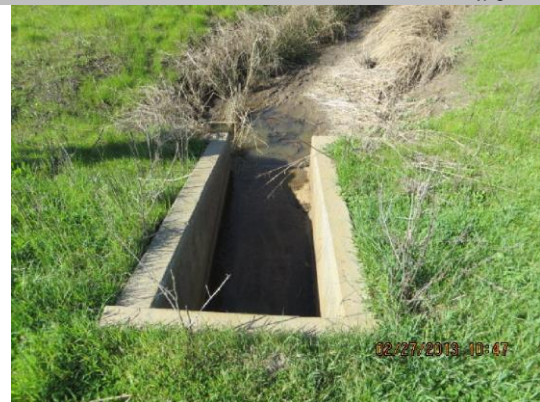
Photo 1 of 3 : UCIP_SP_2019_53548_54247.jpg

LM Start	1.86	Rating **	M	Issue No.	19
LM End	1.86	Issue Type +	Ma	Location *	
Category	Supplemental			GPS Latitude/Longitude	
				Start	End
Item	DWR UCIP LMA Responsibility			39.000975 °	39.000975 °
				-121.537779 °	-121.537779 °
DWR ID	18588				
Comment Code					
Inspector Comment					
FS_ID:53548 DS_ID:18588 EP_NO: N/A Repair Type: Non-Urgent Crossing Status: Found UCIP Comments: 2-1-2019 - Pipe crossing was video inspected on 8/14/2018. (P. Meagher)09/11/2015 Inlet burried. Good candidate for video inspection as pipe is corroded. (G. Wylie - FPIIB) FIELD_STRUCT_DESC: 18-inch corrugated metal drainage pipe through the levee, 14.5 feet below the crown. Flap gate on the waterside (WS) end. Concrete U-shaped headwall on the WS. [Additional Reference(s): DWR Levee Log, 2005. USACE Sacramento O&M Manual 145, August 1955 (Station 116+78)]. FS Date: 9/11/2015 9:36:00 AM

Concrete U-shaped outlet and flap-gate on WS toe.

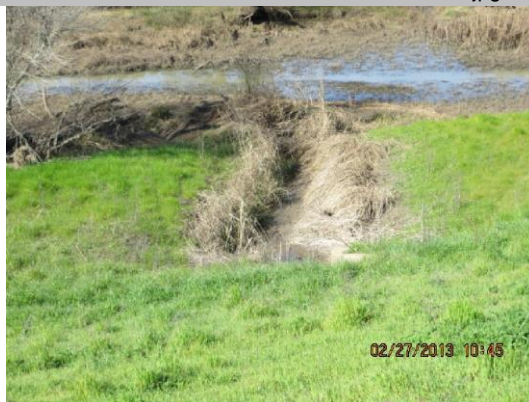
Photo 3 of 3 : UCIP_SP_2019_53548_54249.jpg

Comment Code						
Inspector Comment						
FS_ID:53548						
DS_ID:18588						
EP_NO: N/A						
Repair Type: Non-Urgent						
Crossing Status: Found						
UCIP Comments: 2-1-2019 - Pipe crossing was video inspected on 8/14/2018. (P. Meagher)09/11/2015 Inlet burried. Good candidate for video inspection as pipe is corroded. (G. Wylie - FPIIB)						
FIELD_STRUCT_DESC: 18-inch corrugated metal drainage pipe through the levee, 14.5 feet below the crown. Flap gate on the waterside (WS) end. Concrete U-shaped headwall on the WS.						
[Additional Reference(s): DWR Levee Log, 2005. USACE Sacramento O&M Manual 145, August 1955 (Station 116+78)].						
FS Date: 9/11/2015 9:36:00 AM

Drainage outlet on WS toe.

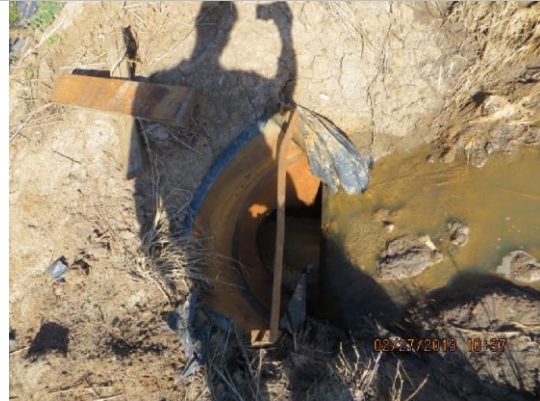
Photo 1 of 3 : UCIP_SP_2019_53557_54250.jpg

FS_ID:53557
DS_ID:18587
EP_NO: N/A
Repair Type: Non-Urgent
Crossing Status: Found
UCIP Comments: 2-1-2019 - The pipe crossing was video inspected on 8/14/2018. New photos of the landside toe added. In August 2017 a sinkhole was noticed at the bottom of the landside toe shelf area. The sinkhole developed as a result of the landowner who extended the existing pipe in order to complete a new unauthorized concrete flashboard structure replacement. The pipe owner was mailed a letter from RD784 with a Cc to CVFPB and DWR dated 10/23/2017 acknowledging the owner's completion of an attempted repair. The sinkhole has since returned. On 1/31/2017 The waterside excess pipe end was discovered to be floating to the surface due to landside water runoff through the pipe. Because of the floating pipe, the water was not draining all the way through the pipe. Instead, the water was overtopping the levee shelf area. In order to resolve this issue, the excess portion of the pipe was cut off. After doing so, the water immediately started draining properly again. (P. Meagher, RD784 2/3/2017). Erosion at outlet may or may not be an issue.

Inlet with PVC weir on LS toe.

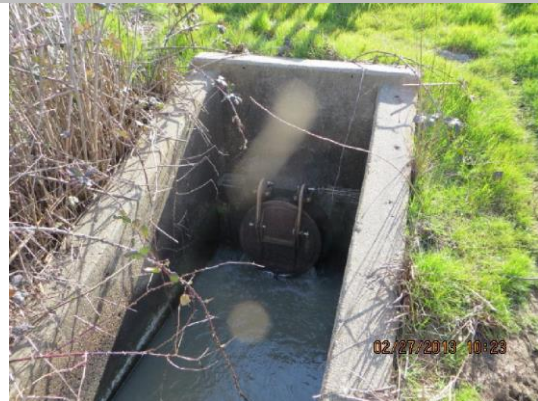
Photo 1 of 3 : UCIP_SP_2019_53540_54258.jpg

11/30/2017 - same as previous inspection - crossing remains Urgent. Received updated photos from DWR levee inspector, S. York, showing current condition of levee LS and WS. (O. Magana - DWR UCIP)

Concrete U-shaped headwall and flap gate on WS toe.

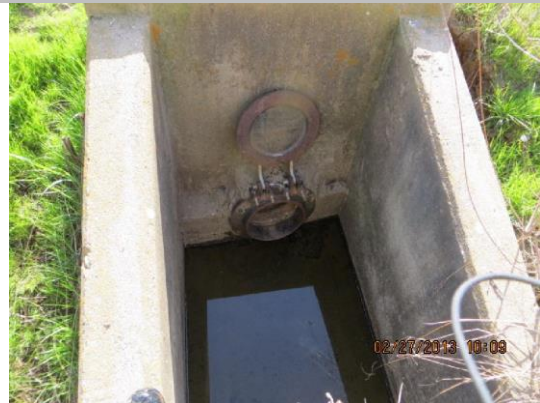
Photo 1 of 3 : UCIP_SP_2019_53553_54259.jpg

Comment Code						
Inspector Comment						
FS_ID:53553						
DS_ID:18596						
EP_NO: N/A						
Repair Type: Non-Urgent						
Crossing Status: Found						
UCIP Comments: 2-1-2019 - Pipe crossing was video inspected on 8/15/2018. (P. Meagher)02/27/2013 Pipe has been sliplined with PVC, but the liner appears to be eroding at outlet and may be disjointed internal to the levee. See pic. Good candidate for video inspection. (W. Wylie - DWR UCIP)						
FIELD_STRUCT_DESC: 12-inch corrugated metal drainage pipe through the levee, 12 feet below the crown. Flap gate and concrete U-shaped headwall on the waterside (WS). Polyvinyl chloride weir on inlet at the landside (LS) toe. [Additional Reference(s): DWR Levee Log, 2005. USACE Sacramento O&M Manual 145, August 1955 (Station 44+96)].						
FS Date: 9/11/2015 9:26:00 AM

Concrete U-shaped headwall and flap gate on WS toe.

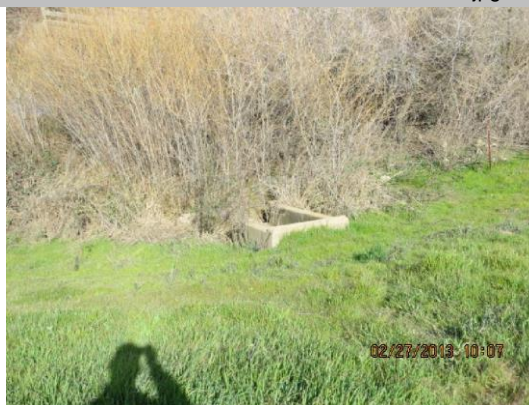
Photo 3 of 3 : UCIP_SP_2019_53553_54261.jpg

Concrete U-shaped headwall on WS toe.

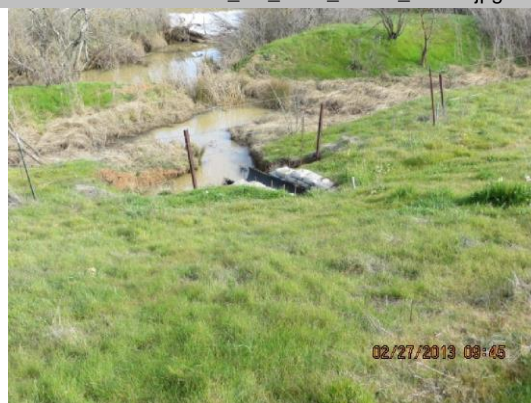
Photo 3 of 3 : UCIP_SP_2019_53551_16592.jpg

LM Start	3.79	Rating **	A/W	Issue No.	24 (cont)	
LM End	3.79	Issue Type +	Ma	Location *		
Category	Supplemental			GPS Latitude/Longitude		
				Start		End
Item	DWR UCIP LMA Responsibility			39.019222 °		39.019222 °
				-121.516414 °		-121.516414 °
DWR ID	18594					
Comment Code						
Inspector Comment						
FS_ID:53551 DS_ID:18594 EP_NO: N/A Repair Type: No Action Needed Crossing Status: Found UCIP Comments: 2-1-2019 - Pipe crossing was video inspected on 8/15/2018. (P. Meagher) FIELD_STRUCT_DESC: 18-inch corrugated metal drainage pipe through the levee, 8.8 feet below the crown. Flap gate and headwall on the waterside (WS) end. [Additional Reference(s): DWR Levee Log, 2005. USACE Sacramento O&M Manual 145, August 1955 (Station 83+39)]. FS Date: 2/27/2013

Concrete outlet on WS toe.

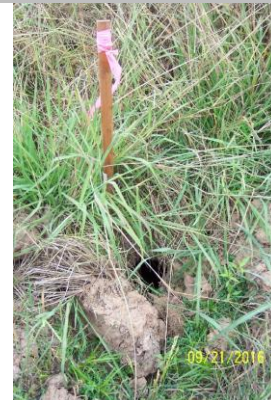
Photo 2 of 3 : UCIP_SP_2019_53550_76148.jpg

Possible location of the inlet on the LS toe

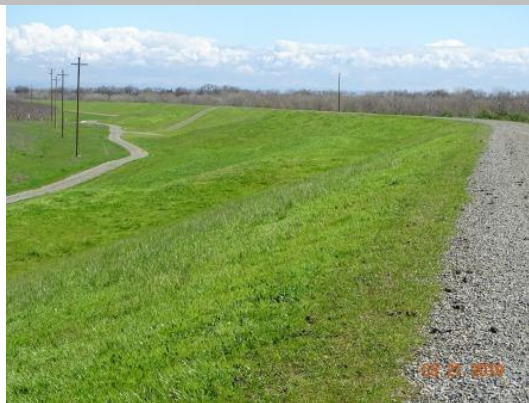
Photo 1 of 1 : SP_2019_RD0784_437_1_20190415_00003.jpg

LM Start	0.06	Rating **	A	Issue No.	1
LM End	1.92	Issue Type +	Ma	Location *	LS
Category	Earthen Levee			GPS Latitude/Longitude	
				Start	End
Item	Vegetation			38.955516 °	38.970437 °
				-121.573792 °	-121.547674 °
DWR ID	DWR_RD0784_08_s_2019_1				
Comment Code					
V1 : Control annual grass and weeds on the levee slopes and easements.					
Inspector Comment					
The annual vegetation is well maintained, Spring 2019.

View looking upstream landside at the well maintained annual vegetation, Spring 2019.

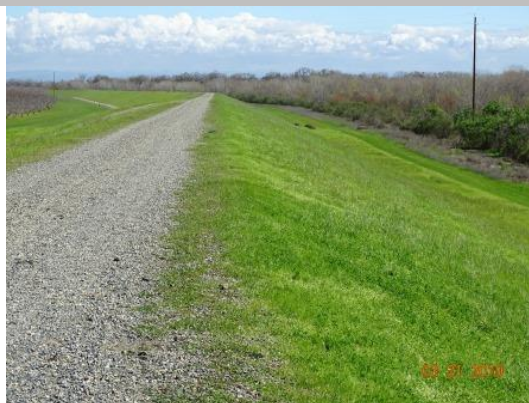
Photo 1 of 1 : SP_2019_RD0784_437_2_20190415_00004.jpg

LM Start	1.92	Rating **	A	Issue No.	2
LM End	1.92	Issue Type +	Ma	Location *	WS
Category	Earthen Levee			GPS Latitude/Longitude	
				Start	End
Item	Vegetation			38.970436°	38.970437°
				-121.547674°	-121.547674°
DWR ID	DWR_RD0784_08_s_2019_2				
Comment Code					
V1 : Control annual grass and weeds on the levee slopes and easements.					
Inspector Comment					
The annual vegetation is well maintained, Spring 2019.

View looking upstream landside at the well maintained annual vegetation, Spring 2019.
